# ARMENIAN MEDIEVAL ARCHITECTURE: EARTHQUAKES AND RESTORATION

*arch. Gaiànè Casnati,*

CENTRO STUDI E DOCUMENTAZIONE DELLA CULTURA ARMENA

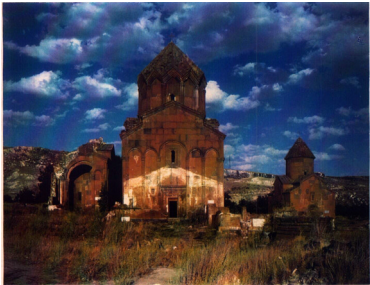
<b>description</b>	MARMASHEN MONASTIC COMPLEX

<b>title (first three letters of the name of monument, serial number)</b>	Mar24	
<b>date of photo/design</b>	26/09/00	
<b>date of insertion (dd/mm/yy)</b>	02/10/2000	
<b>Name of the complex</b>	MARMASHEN	
<b>file maker (code number of the operator)</b>	6	
<b>File + directory</b>	mar24.jpg + Armenia/Shirak/Marmashen	
<b>name of building/dedication</b>	<i>hyussissi yegetzi</i> (chiesa nord), <i>Marmasheni kikhavor yegetzi</i> (chiesa madre di M.)/Surp Stepanòs, <i>pokr yegetzi</i> (chiesa piccola)	
<b>nation</b>	Republic of ARMENIA

<b>actual/historical Region</b>	Shirak/Shirak
<b>city/village</b>	Vahramaberd
<b>date of construction</b>	988-1029
<b>designer/donor-builder (in the manuscripts the donor is often indicated as the "builder")</b>	architect Drtat (?)/prince Vahram Pahlavouni
<b>Internal/external view</b>	external view
<b>Type of view</b>	General view
<b>Location</b>	in a valley, near the river Axurian
<b>Orientation</b>	west
<b>Type of building</b>	Longitudinal plan, domed hall
<b>Building materials / construction techniques</b>	red-brown tufa, mortar of lime sand and pumice stone / sacco wall
<b>Earthquakes / distructions</b>	1064 destruction by the Seljuks, 1139 earthquake MSK 9-10, 1275 earth. MSK 9, 1668 earth. MSK 6-7, XIX c. destructions dued to the war and the robbery of the stones, 1920 the church was burnt, 1926 earth. MSK 9, 1988 earth. MSK 9, 1995 earth. MSK 5
<b>Reconstructions / restorations</b>	1225, XIX c. by Catholicos Khrimian Hayrig, 1903 first archaeological excavations, 1932-1948 excavations, surveys and studies, 1945 restoration of the "little church", 1950 renewed th roof os S. Stepanos, 1954-55 new restoration works on the complex, 1954-56 archaeological excavations, 1970 installed signs and engaged a keeper, 1995 installed anti-bird nets and extensimeters to monitor the micro movements of the cracks, 1999 archaeological excavations of the gavit, july 2000-nowaday structural consolidation works

<b>state of conservation (very sinthetic)</b>	several problems of conservation, urgent intervention needed
<b>problems of conservation (accurated description of the problems related to the monument or part of the monument represented in the picture)</b>	the north church has serious problems of stability and needs very urgent itervention, the archaeological remains need to be studied and preserved, the walls of the gavit must be strenghtened, the roof and, mostly, the paving of the little church are decayed, the little church presents problems related to humidity, there is everywhere the need of a cleaning from vegetation.
<b>Decoration settings</b>	blind column and arches, typical of the buildings of the "Ani school", the sculpted motifs of the frames, portal and windows are related to the classical tradition (e.g. ovuli, dentils, etc.)
<b>References</b>	in Armenia see the churches of Amberd (XI c.) and Ketcharis (XI-XIII c.), in Turkey see the churches and the cathedral of Ani (X-XI c.), in Italy see the romanic churches of Puglia and Tuscany (cfr. A. Alpago Novello, "L'architettura armena e l'Italia", in GLI ARMENI IN ITALIA, De luca, Roma, 1990)
